**U.S. Department
of Transportation
Federal Highway
Administration**

**LTPP Seasonal Monitoring
Program
Site Monitoring Suspension
Status Report
Section 364018, Oneonta
New York**

SMP SITE MONITORING SUSPENSION STATUS REPORT NEW YORK SECTION 364018

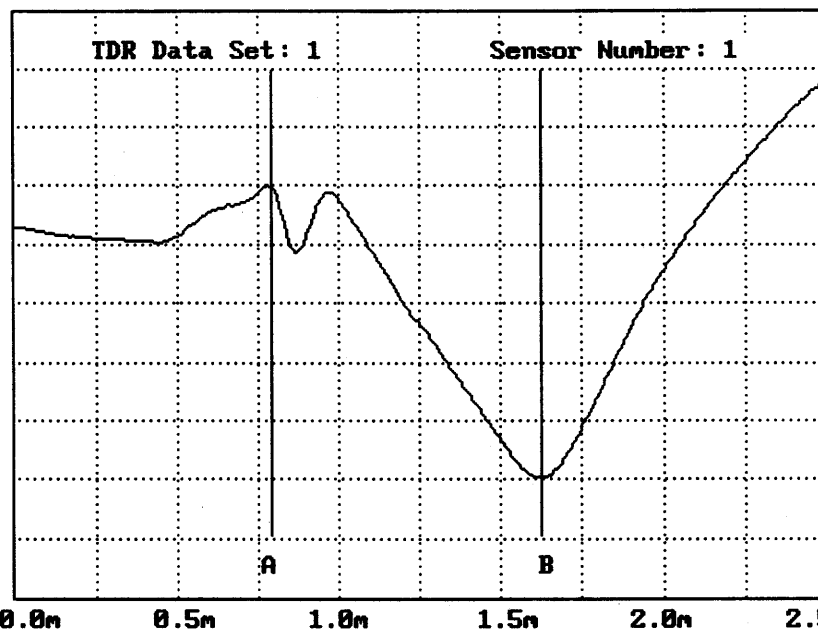
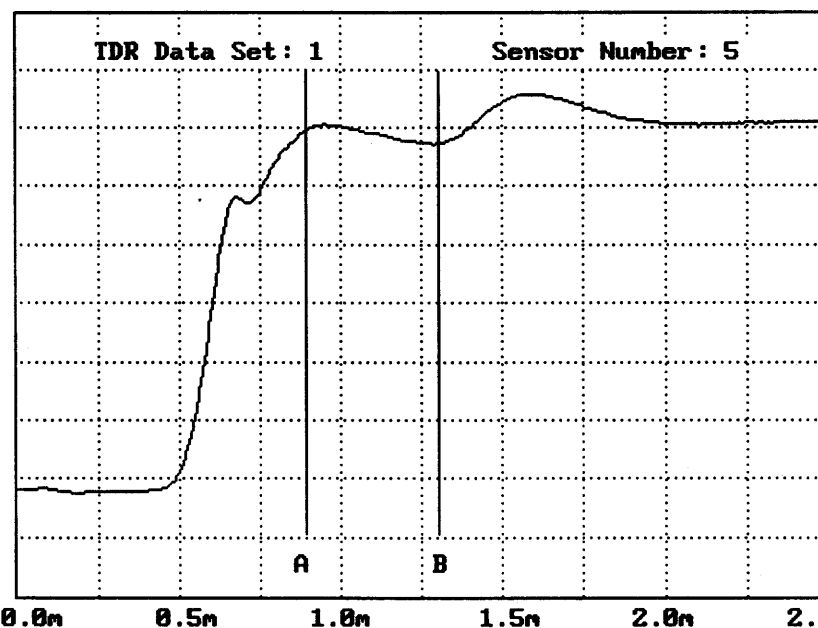
TDR sensor number five was not producing expected traces at the time of the suspension. Other than TDR sensors number one and five, there were no unresolved problems with any of the sensors. The traces for these sensors are shown in figure 3. All other plots from ONSFIELD, MOBFIELD, and SMPCHECK follow expected trends and produce expected values.

A (m) = 0.79
B (m) = 1.62
Trace Length (m)=0.83
Diele. Const.= 17.0
Volumetr MC (%)= 30.6

A (m) = 0.89
B (m) = 1.30
Trace Length (m)=0.41
Diele. Const.= 4.2
Volumetr MC (%)= 5.9
